# **INDOOR AIR QUALITY ASSESSMENT**

**Massachusetts Division of Capital Asset Management  
and Maintenance (DCAMM)  
Energy Group  
One Ashburton Place, 16<sup>th</sup> floor  
Boston, MA**

Prepared by:  
Massachusetts Department of Public Health  
Bureau of Environmental Health  
Indoor Air Quality Program  
April 2017

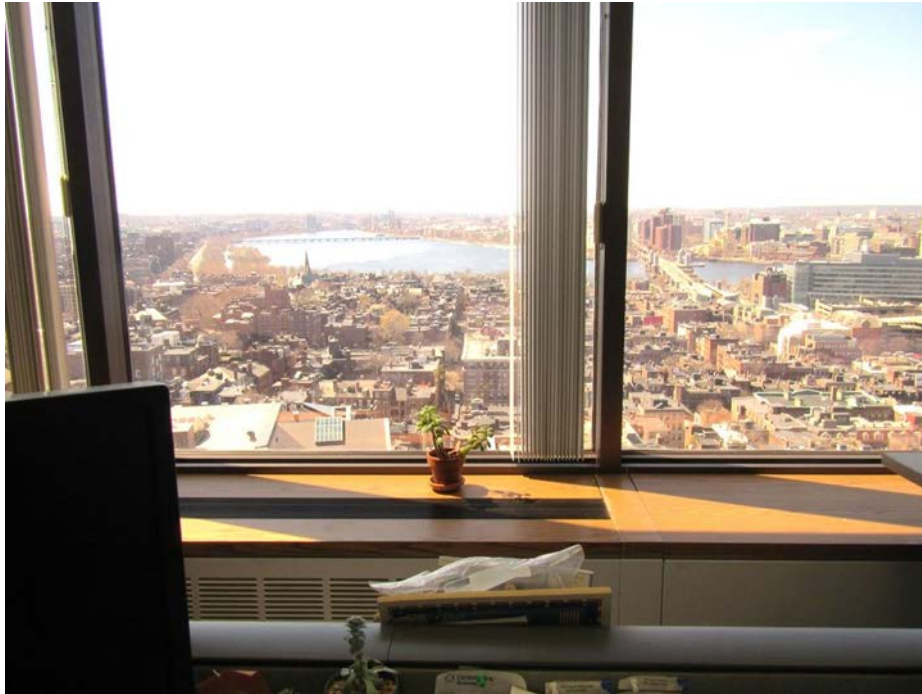
**Picture 1**

Fresh air is supplied by induction units located along the outer edges of the building (Picture 1). Return air is drawn around light fixtures using ducted returns. Fewer induction units had items on them than during the last visit. Induction unit vents should be kept free of items and kept clean.

No water-damaged ceiling tiles or other materials were observed during the visit. Plants were noted in a few areas (Table 1; Picture 1). Plants can be a source of pollen and mold, which can be respiratory irritants to some individuals. Plants should be properly maintained and equipped with drip pans and should be located away from induction units to prevent the aerosolization of dirt, pollen and mold.

**Induction unit, note plant**

1. Operate supply and exhaust ventilation continuously in all areas during occupied periods. Ensure all HVAC equipment is cleaned/maintained in accordance with manufacturer's instructions. Avoid blocking HVAC equipment with boxes, furniture or other items.

4. Keep plants in good condition, avoid overwatering, and remove from the airstream of heating and ventilation equipment.
5. Consider the use of waterproof mats underneath water dispensers to protect carpet.

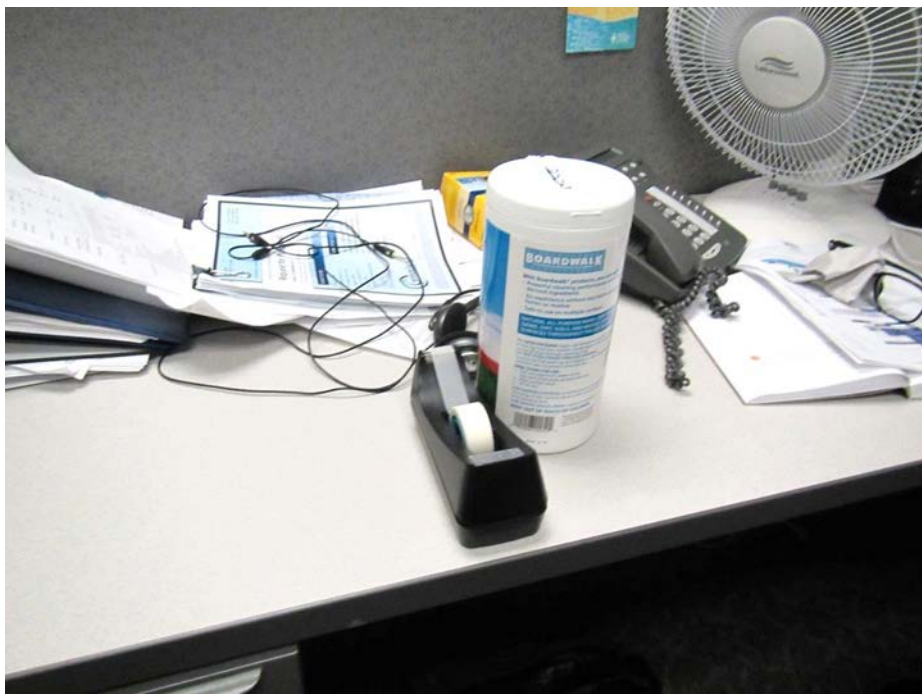
**Picture 2**

Exposure to low levels of volatile organic compounds (VOCs) may produce eye, nose, throat, and/or respiratory irritation in some sensitive individuals. BEH/IAQ staff examined spaces for products containing VOCs, noting air fresheners, deodorizers, hand sanitizers, cleaning products, and dry erase materials in a number of areas throughout the office space (Table 1; Picture 2). All of these products have the potential to be irritants to the eyes, nose, throat, and respiratory system of sensitive individuals.

Personal fans observed in some offices appeared dusty, as were the supply and return fins of some of the induction units. This dust can be reaerosolized and is a respiratory and eye irritant. Fans and induction units should be cleaned periodically to prevent aerosolization of dust when the units are activated.

**Cleaning wipes and dusty personal fan**

6. Consider replacing carpeting in the kitchen area with tile.
7. Reduce the use of cleaning products, sanitizers, and other items that contain VOCs.
8. Consider if direct exhaust ventilation is feasible for the kitchen/copy area. Ensure the copy machine is well maintained to reduce VOCs, ozone, particulates and odors.

10. Clean blades of personal fans to prevent aerosolization of dust.
11. Reduce the amount of items stored on flat surfaces to allow regular cleaning.
12. Refer to resource manual and other related IAQ documents located on the MDPH's website for further building-wide evaluations and advice on maintaining public buildings. These documents are available at: <http://mass.gov/dph/iaq>.

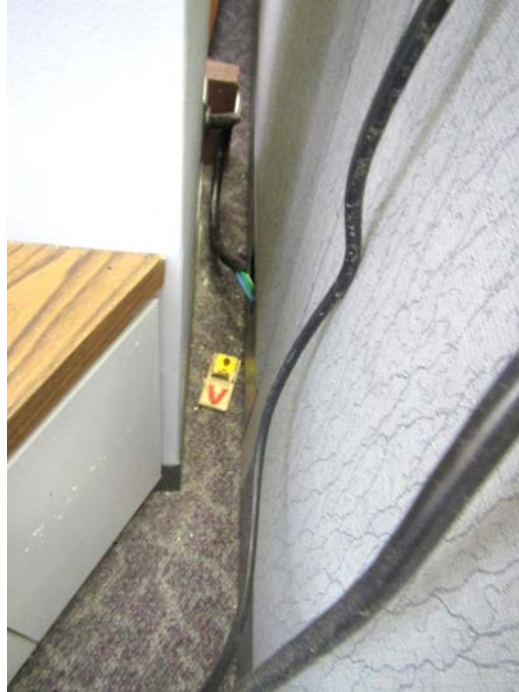
**Picture 3**

Rodents were reported in this office on an occasional basis. A mousetrap was observed behind some of the cube walls (Picture 3). Rodent infestation can result in IAQ related symptoms due to materials in their wastes. Mouse urine contains a protein that is a known sensitizer (US EPA, 1992). A sensitizer is a material that can produce symptoms (e.g., running nose or skin rashes) in sensitive individuals after repeated exposure. To eliminate exposure to allergens, rodents must be removed from the building. Please note that removal, even after cleaning, may not provide immediate relief since allergens can exist in the interior for several months after rodents are eliminated (Burge, 1995). Once the infestation is eliminated, a combination of cleaning and increased ventilation and filtration should serve to reduce allergens associated with rodents. It was reported that steam cleaning of the carpeting was planned for soon after this visit.

**Mousetrap behind cube walls**

9. Use the principles of Integrated Pest Management (IPM) and the services of a licensed pest control operator to remove rodents and reduce the potential for pest infestation. Ensure that any area where rodents may have been is thoroughly cleaned to remove allergens.
